Oman Transport Safety Bureau (OTSB)

Preliminary Report

OTSB Case File No: AIFN-003/05/2025

Tyre Failure and Loss of Hydraulics Oman Air Aircraft Boeing 737-800 MAX - A4O-ML at Muscat (MCT) International Airport (OOMS), Oman.

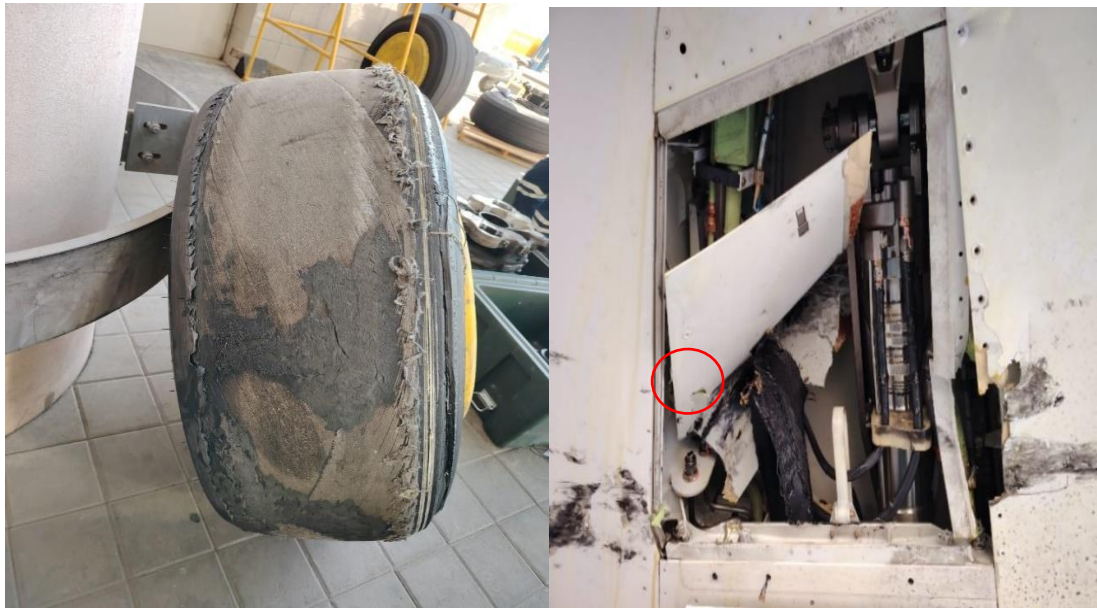
- 1.3.1 Damages were sustained on the tires, access panels, left hand inboard flap, Krueger flaps and hydraulic pipes.

Figure 1 showing damages on the left-hand main tire, HYD pipes as indicated by red cycle and broken access panel.

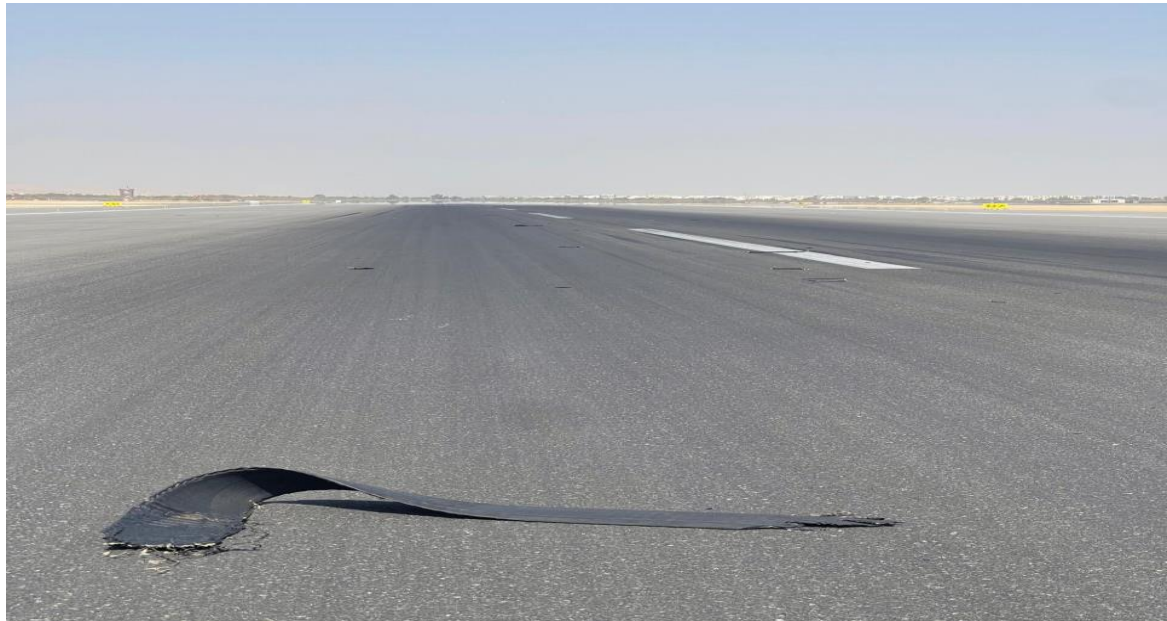
1.12.1 The flight crew of aircraft OMA815 took off from RWY 26L shortly after airborne, the flight crew of aircraft OMA231 reported to APP ATCO that there were presence of tire debris on the runway. The aircraft OMA815 sustained damages on the wheel tires of wheel 1 only and there were reported structural damages to the following: main wheel No.1 de-capped, access panel above left hand (LH) landing gear, hydraulic lines were also broken and ruptured, the left hand inboard (LH INBD) FLAP, Krueger flap also damaged and the left-hand engine cowling, inboard tire and brake No.1 were also damaged.

Figure 4: showing evidence of Main Wheel tire number 1 de-capped threat from the tire (Source: Oman Airports).

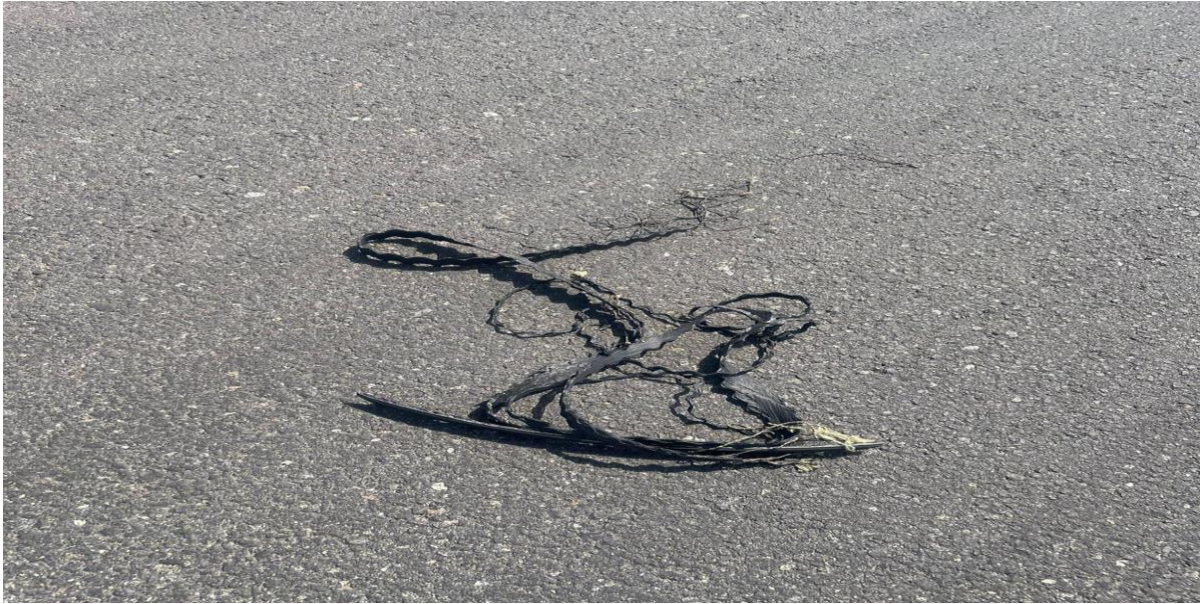
Figure 6: showing evidence of Main Wheel tire debris after tire de-capping (Source: Oman Airports).

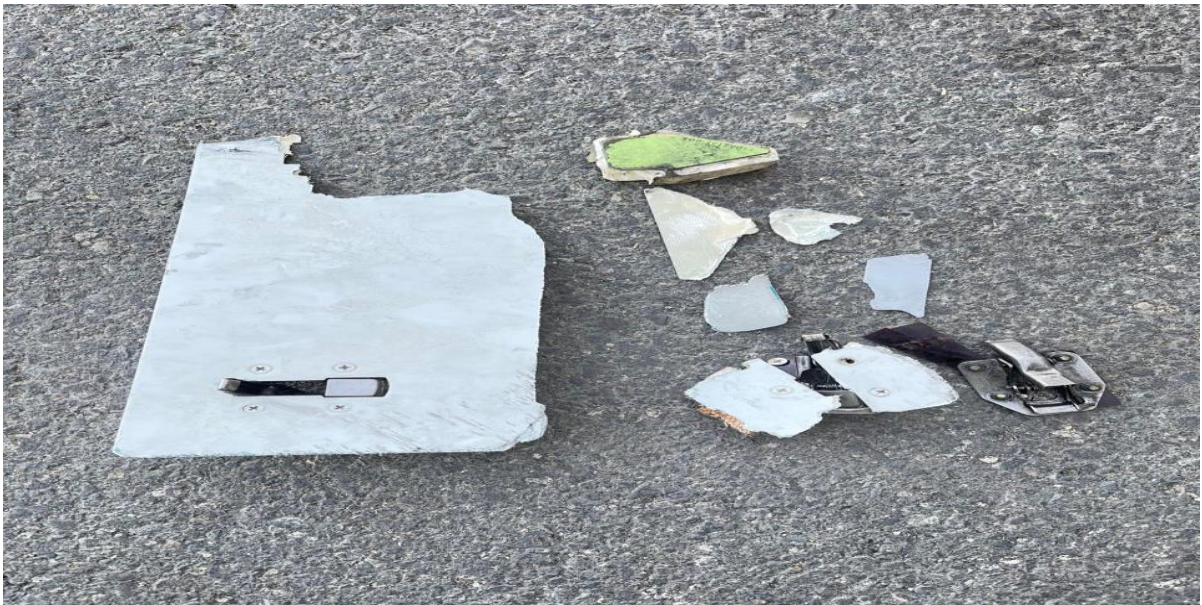
Figure 7: showing evidence of damaged access panel above left hand (LH) (Source: Oman Airports).
