Oman Transport Safety Bureau

Preliminary Report

OTSB Case File No: AIFN-006/10/2024

Salam Air A321-235N Ground Proximity Warning System (GPWS) Serious Incident

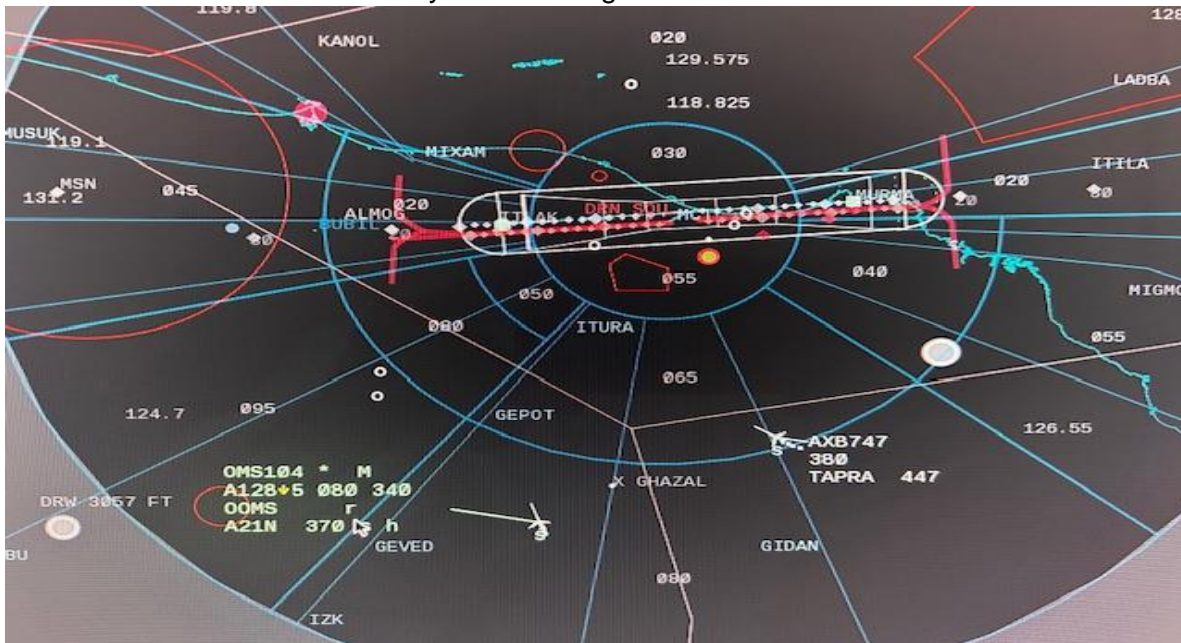
Figure 1: showing aircraft OMS104 observed on radar passing through 12800ft descending to 8000 Ft at ROD 500 feet per minute (FPM) (Source: DGAN)

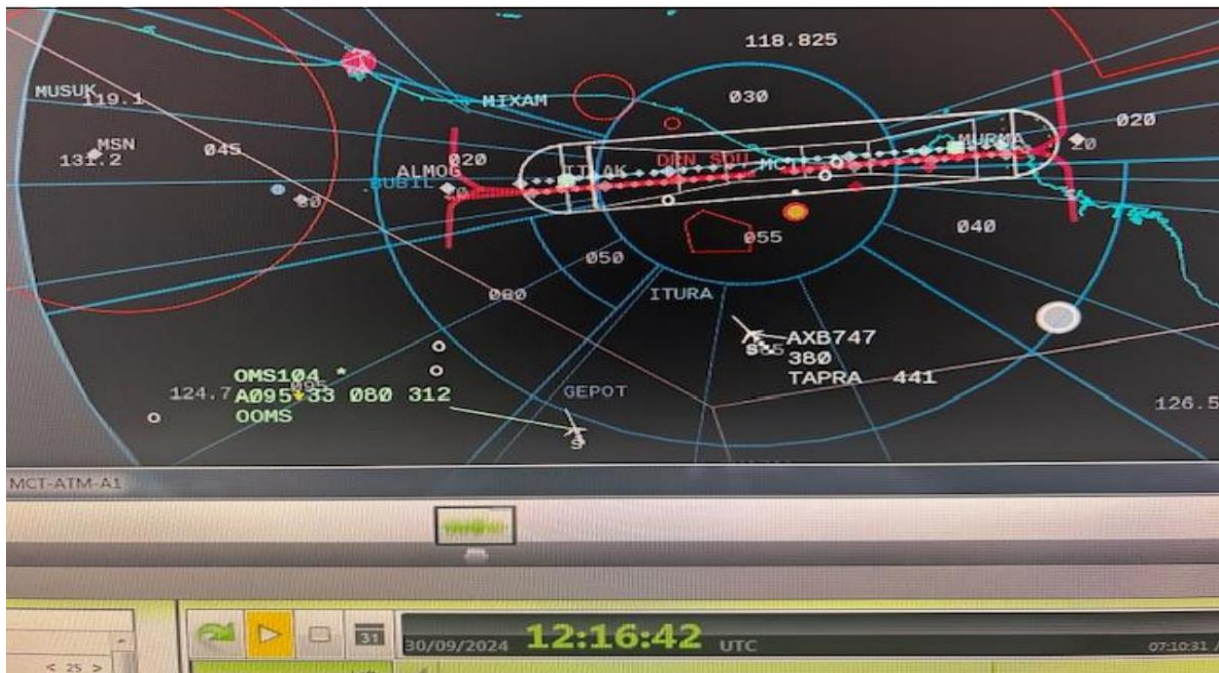
Figure 2: showing aircraft OMS104 observed on radar passing through 9500Ft at a ROD3300 FPM descending to 8000Ft (Source: DGAN)

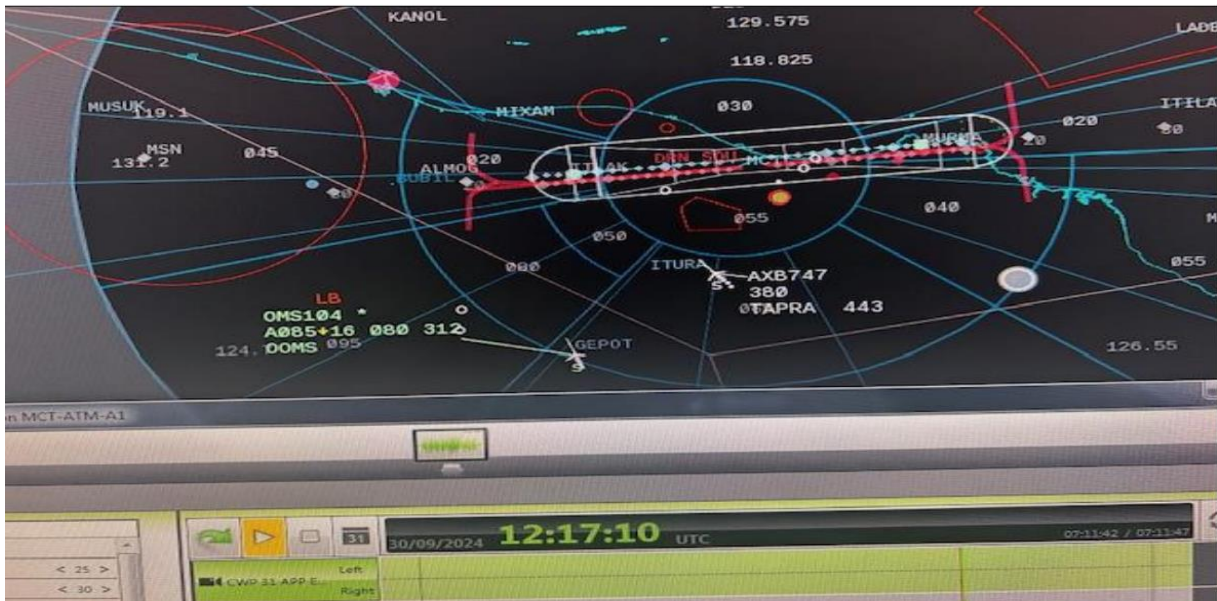
Figure 3: showing aircraft OMS104 observed on radar passing through 8500 Ft at ROD 1600 FPM descending to 8000 Ft (Source: DGAN)

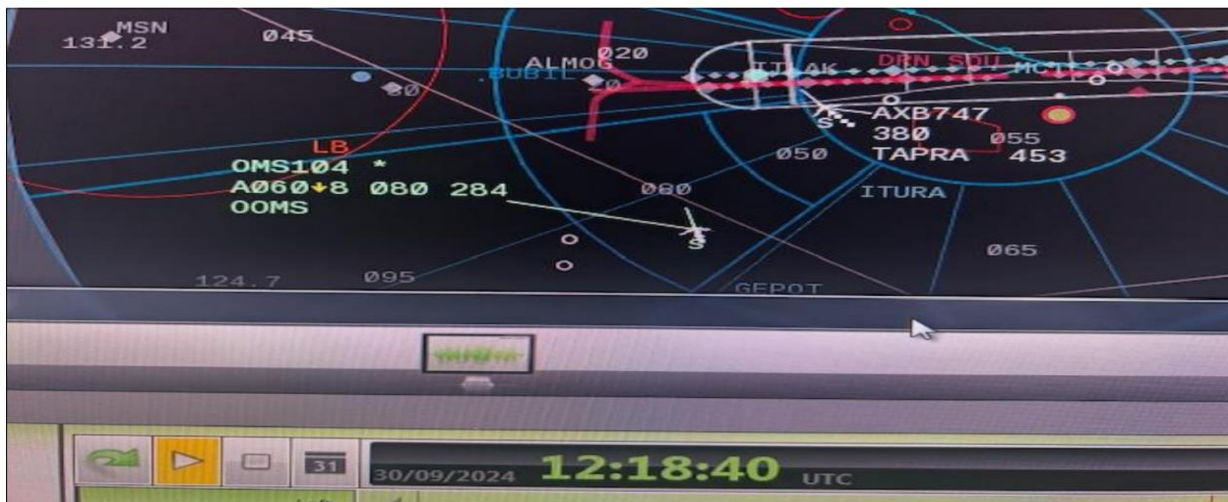
Figure 4: showing aircraft OMS104 observed on radar on passing through 6000ft ROD of 800 FPM descending to 4000 Ft (Source: DGAN)

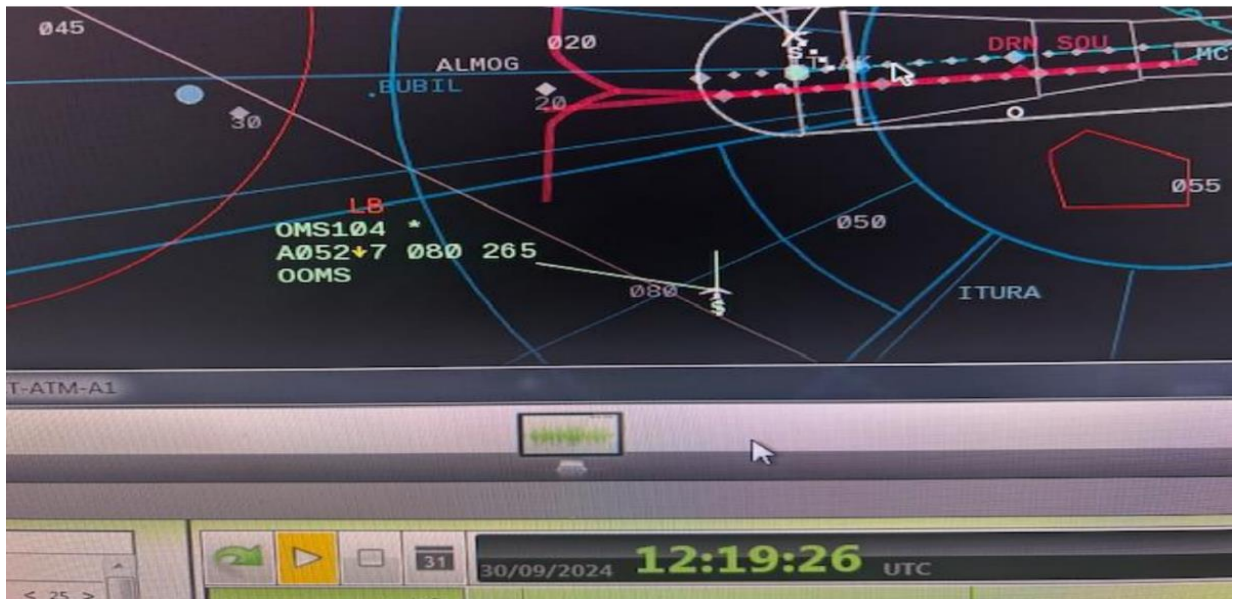
Figure 5: showing aircraft OMS104 observed on radar descending through 5200ft at ROD of 700FPM descending to 4000 Ft (Source: DGAN)

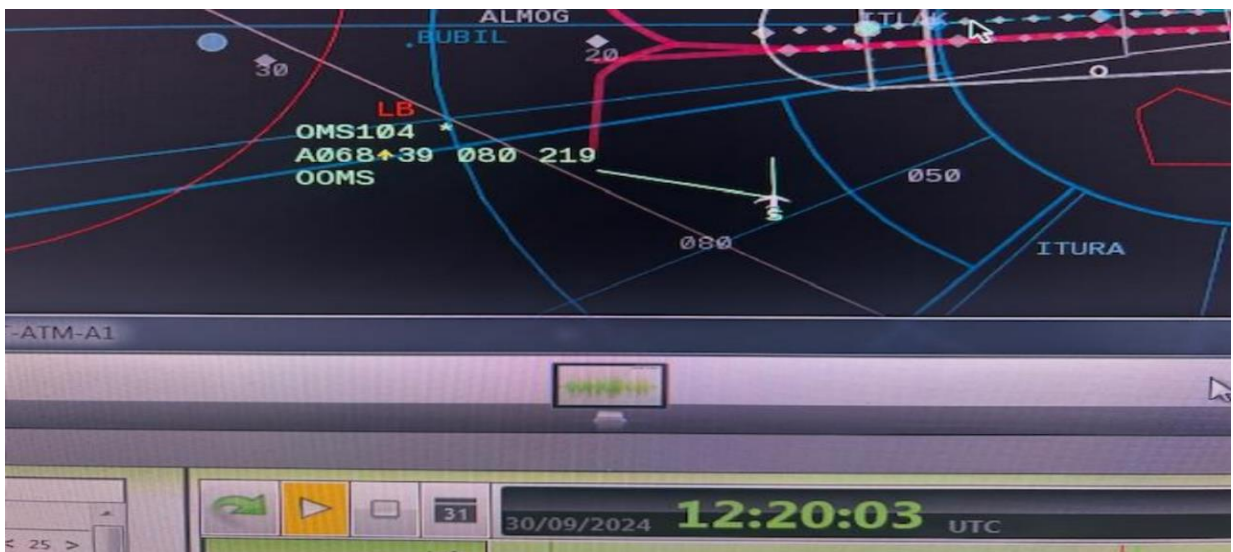
- 1.1.14 At the time 12:19:30 the EGPWS warning triggered to "Pull Up terrain" to which the flight crew of aircraft OMS104 applied memory action procedures and the flight crew of aircraft OMS104 advised ATCO.
- 1.1.15 At 12:20:02 the crew set climb to above Minimum Safety Altitude (MSA) 8000 Ft and they requested vectors for ILS 08L and normal ops thereafter. All procedures were followed and the safe conduct of the flight was always ensured.

Figure 6: showing aircraft OMS104 observed on radar passing through 6800 Ft at ROC of 3900FPM climbing to 8000 Ft (Source: DGAN)

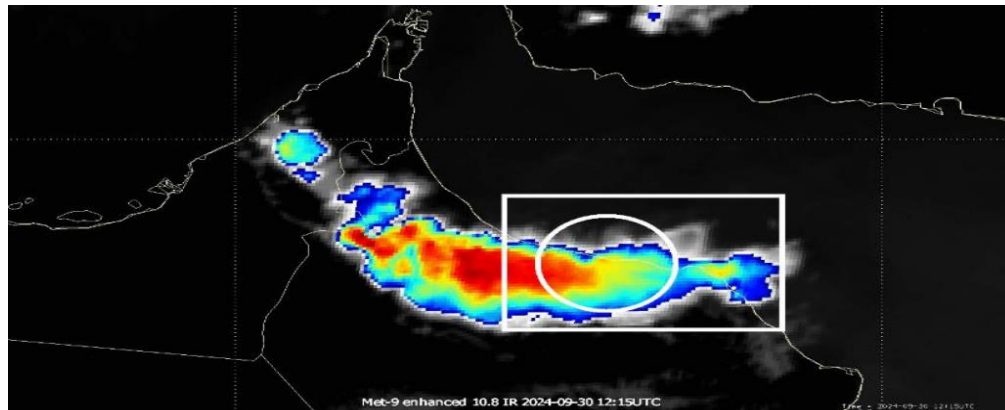
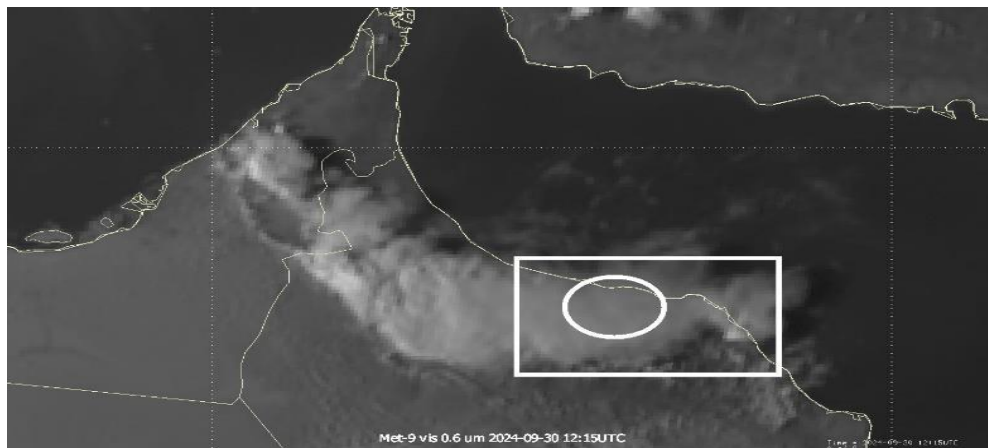
Satellite show convective cloud over area may be CB cloud as showed in figures 7 and 8. Expected low cloud and convective cloud over the area and during time of incident Figure 7. Convective cloud can be found CB extend up to 3900ft associated with Thundershower rain, downdraft wind, wind shear and turbulence.

Figure 7: showing satellite image at the time 1200Z on the 30th September 2024

Figure 8: showing satellite image at the time 1200Z on the 30th September 2024

- 1.7.4 Significant weather condition was observed from the satellite image during the time of the incident over Oman FIR especially over Alhajar mountain during time at (1215UTC) and covering the position of incident aircraft.

There was convective cloud around in the location of the incident and expected type of CB clouds which was extended up to 12000m (39000ft) approximately and associated thundershower rain, hail, downdraft, strong variable winds, strong windshear, lighting and air turbulence.

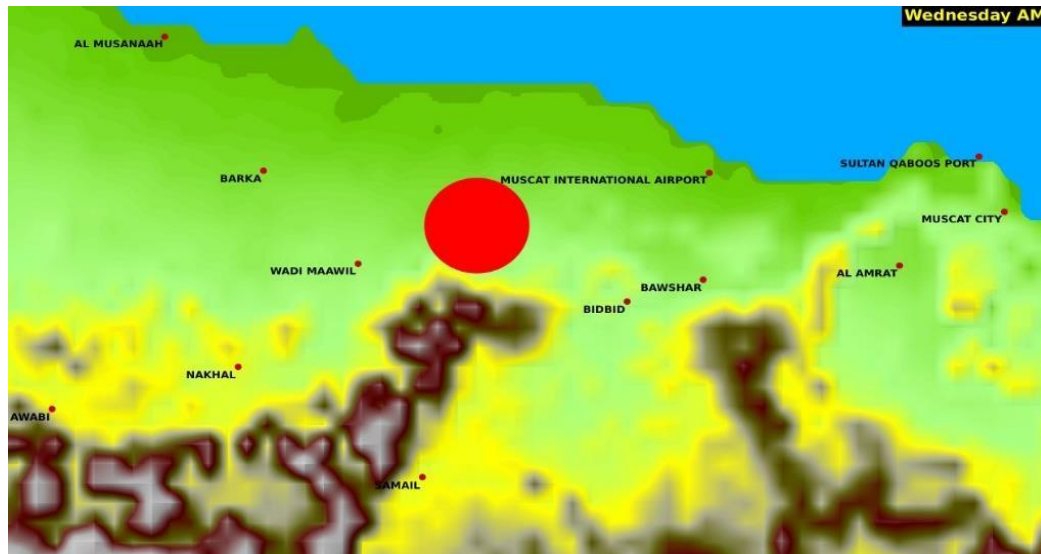
Figure 12: showing position of incident 23.415395N 057.992873 E (see red circle)

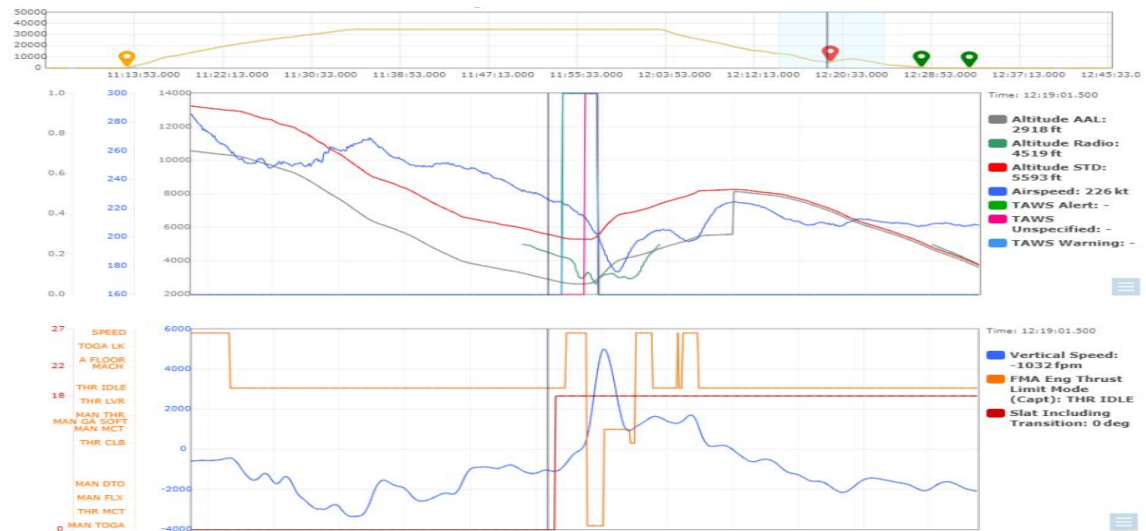
1.1.13 As per the aircraft Flight Data Monitoring (FDM) recording between 12:15:00 and 12:20:00 the aircraft OMS104 got EGPWS caution message “terrain ahead” and the flight crew of aircraft OMS104 selected vertical speed to zero while flying level at green dot.

Figure 13 indicates TAWS warning, Vertical Speed and Thrust Mode (OMS104)

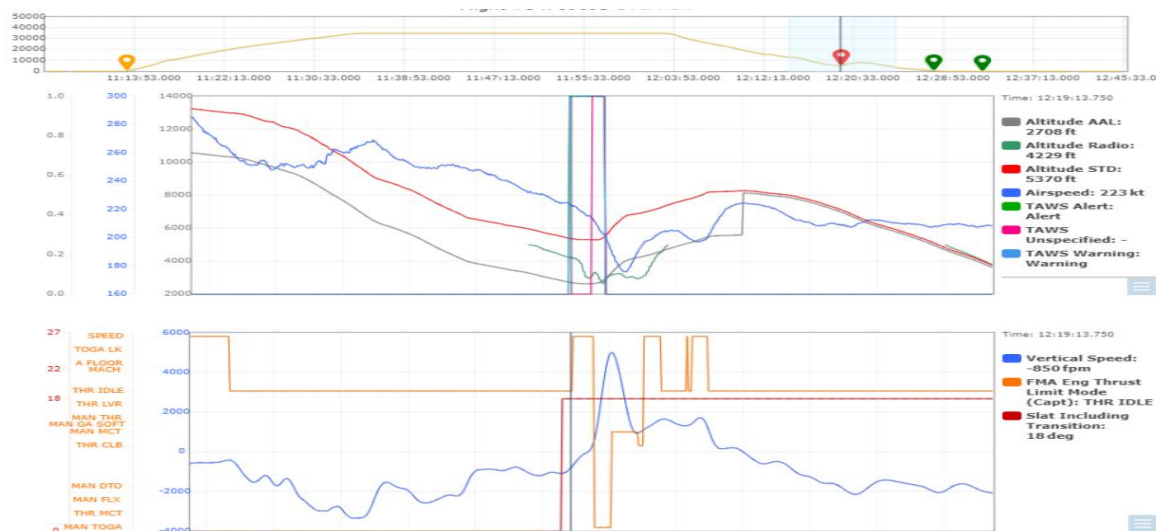
Figure 14 indicates TAWS warning, Vertical Speed, Thrust Mode and Config 1 selected (OMS104)

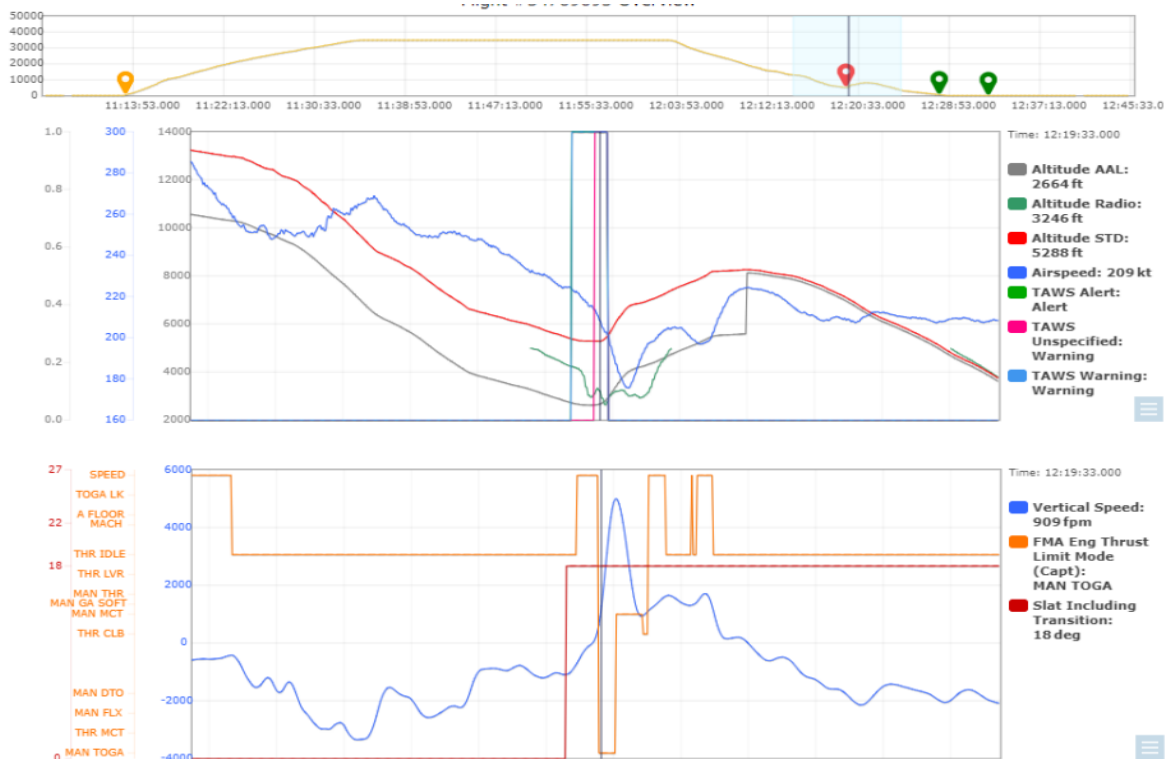
Figure 15: indicates GPWS recovery Action (OMS104)
