Oman Transport Safety Bureau

Preliminary Report

OTSB Case File No: AIFN-005/07/2024

Runway Excursion (RE) at Muscat International Airport (OOMS) on Runway 08L

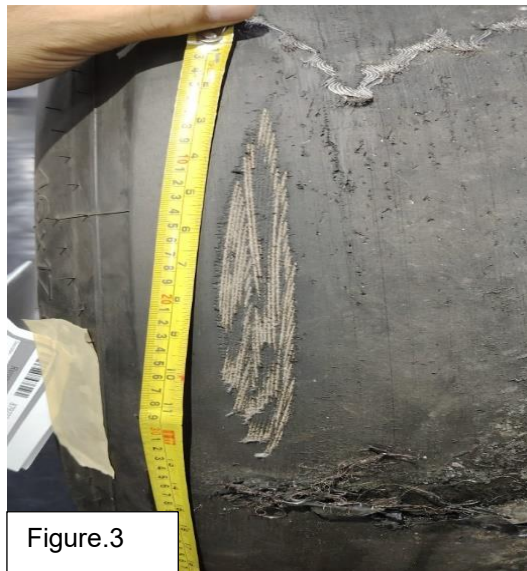
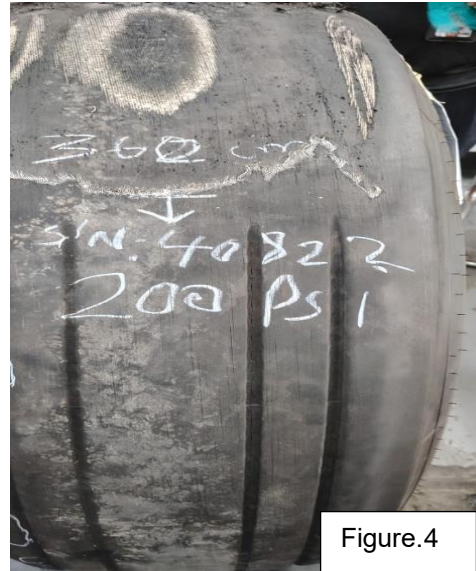
Figure.3

- 1.3.1 Damage was limited to the tires.

Figure 3 and 4: Showing damages sustained on the right main tires

- 1.1.21 Following the tires replacement by the Aircraft Maintenance Engineers (AME), both the LGCIU and NWS were reset and the system check was found satisfactory after the tests. The aircraft SAW781 was certified and released to serviceable and flown back to Damascus International Airport (OSDI).

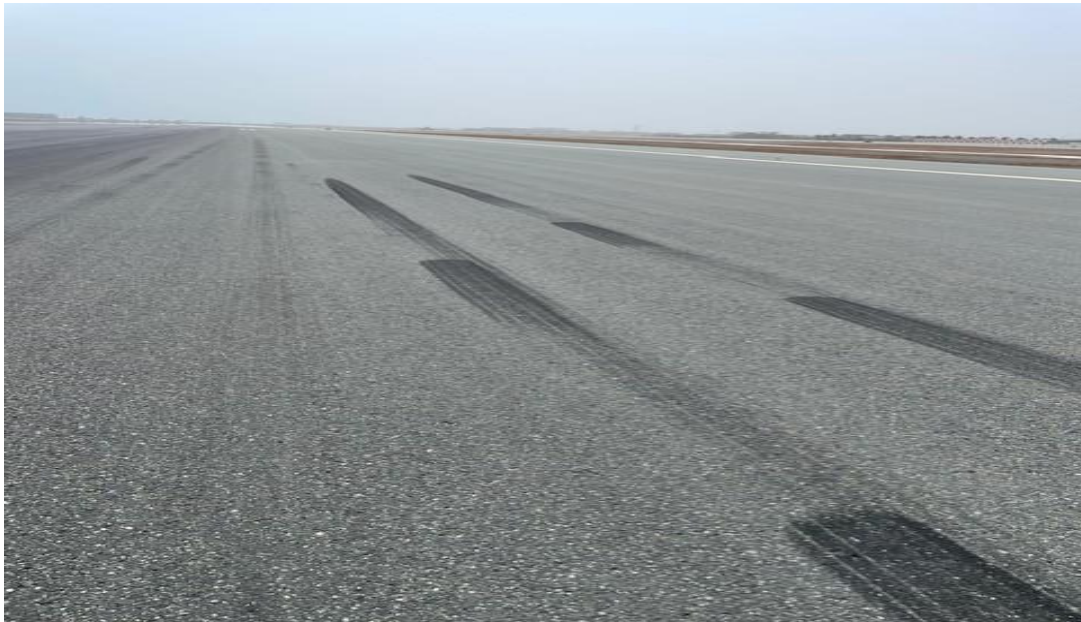
Figure 9: showing the first touchdown tire marks on Runway 08L

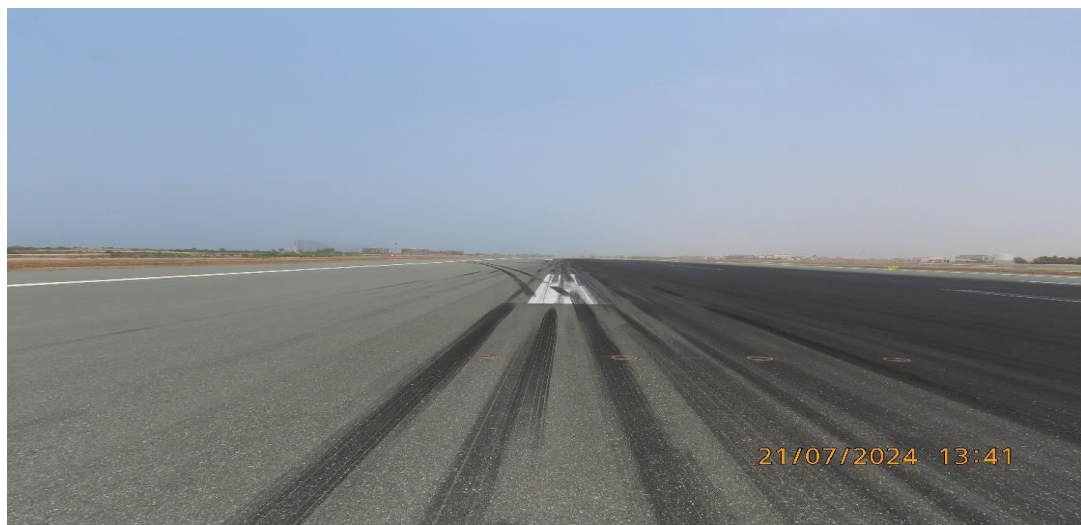
1.12.1 The aircraft landed smoothly and normally on Runway 08L. During rolling out and deceleration, approximately 3.1 kilometers (KM) from the threshold, the aircraft then started drifting to the left of Runway 08L center line and stopped just after the runway edge line. The incident occurred between taxiway Y5 and taxiway Y6.

Figure 10 showing the tire marks before the aircraft veered off to the left of Runway 08L

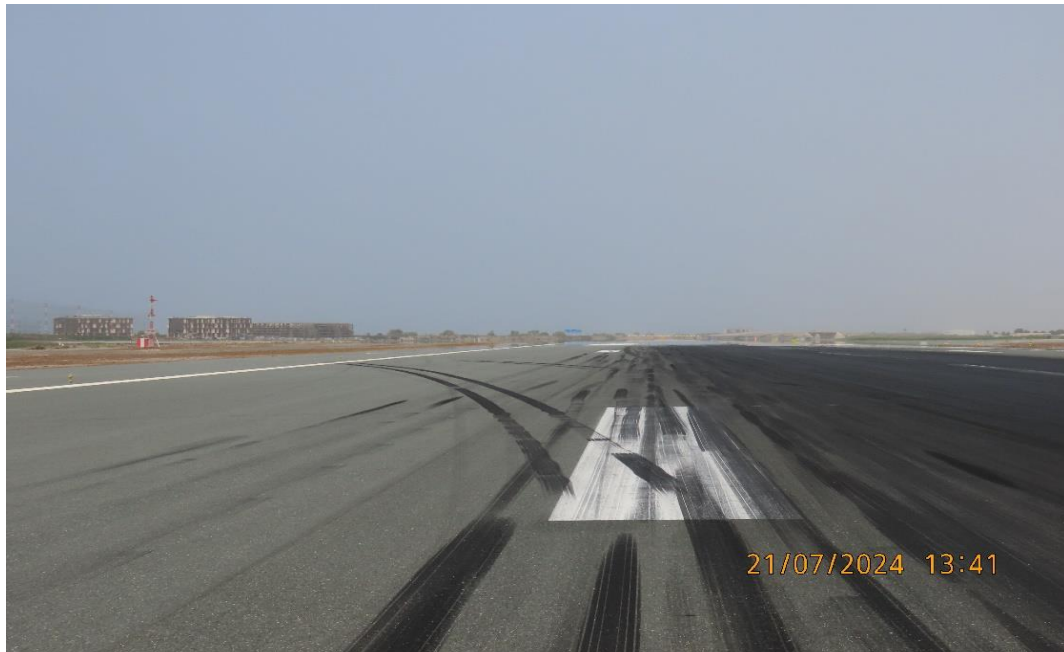
Figure 11: showing Left-Hand Main Undercarriage tire marks veering to the left of Runway 08L.

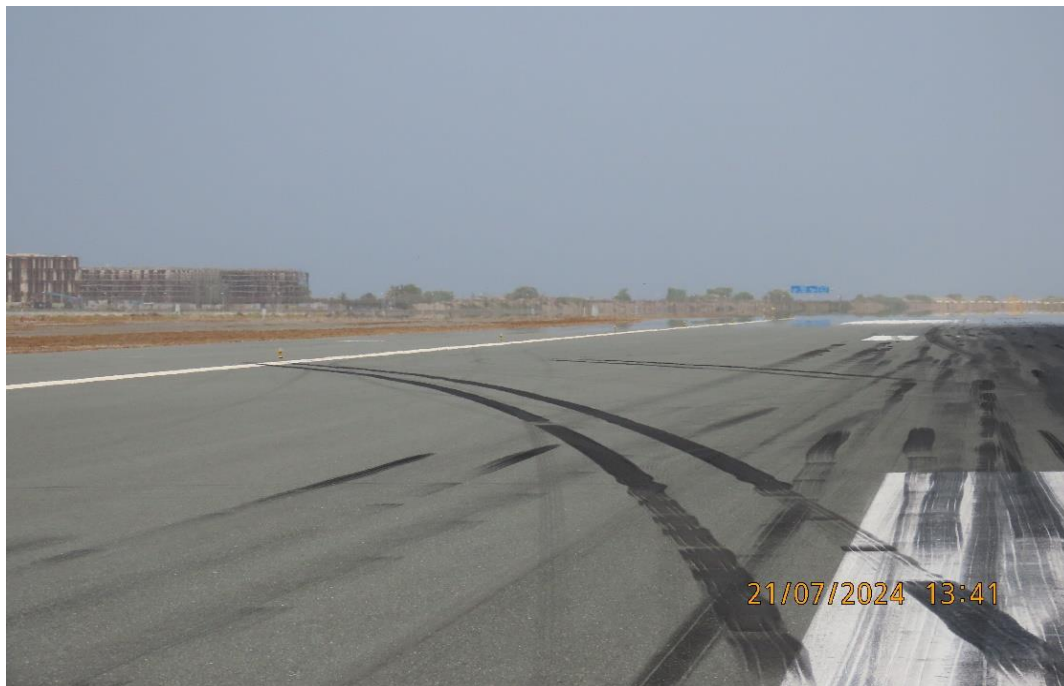
Figure 12: showing tires marks turning to the left of Runway 08L edge

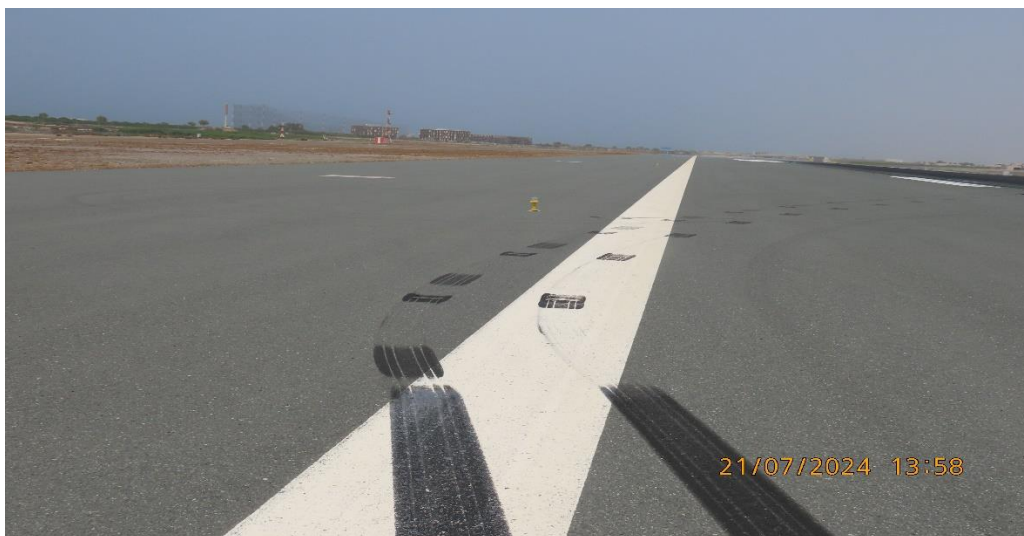
Figure 13: showing tire marks outside the left edge of the runway and back into the runway, this was at the time the aircraft turning to the Right Towards Taxiway Y6
