Oman Transport Safety Bureau (OTSB)

Preliminary Report

OTSB Case File No: AIFN-002/05/2025

Runway Incursion (RI) between Oman Aviation Academy (OAA)
Aircraft - A4O-OAI and A4O-OAG at Sohar International Airport (OOSH),
Oman.

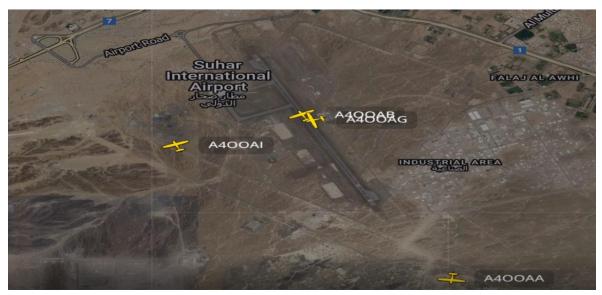
- 1.1.4 According to the operator, it was a busy morning with four company aircraft operating in the vicinity which were A4O-OAI, A4O-OAG, A4O-OAA, A4O-OAB. See figure 1 below.

Figure 1 - Positions of aircraft at start of taxi (Source: Operator).

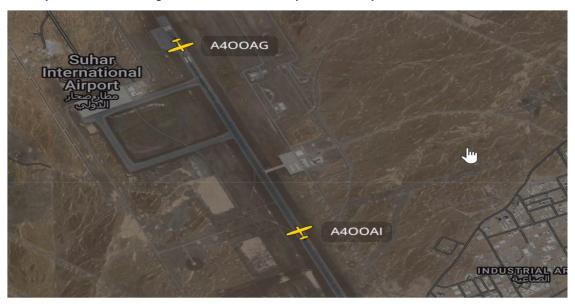
1.1.6 At 04:20The solo student pilot of aircraft A4O-OAG entered the active RWY towards the beginning of the Threshold of runway 15, made 180 degrees turn and reported ready for departure and Sohar AFISO replied (Take-off at your discretion). The solo student pilot of aircraft A4O-OAG then started his Take-Off without realizing that aircraft A4O-OAI was still on Runway 33 back tracking to vacate the runway via taxiway B4.

Figure 2 - Positions of aircraft at A4O-OAG and A4O-OAI prior to take-off (Source: Operator).

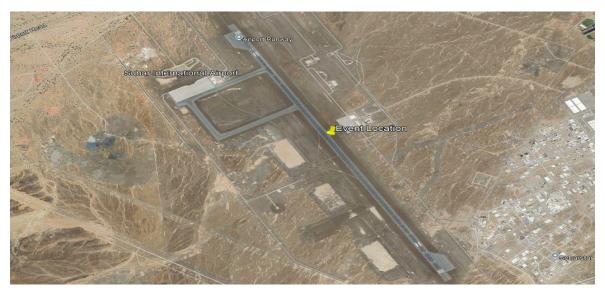
- 1.1.10 The solo student pilot flying aircraft A4O-OAG passed behind the aircraft A4O-OAI which had started vacating the runway via taxiway B4, at 600 feet (Ft) Above Mean Sea Level (AMSL).

Figure 3: Shows the position where the serious incident happened (Source: Operator).

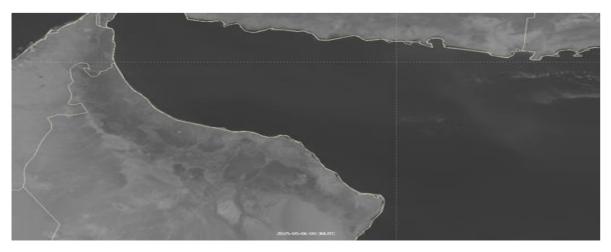
1.7.3 According to Directorate General of Meteorology (DGMET) office, satellite image was observed with no Significant weather condition over Oman FIR. Satellite imagery and METAR observations indicate stable atmospheric conditions over Sohar Aerodrome and across the region. Skies remain clear, with no significant cloud development or convective activity observed, consistent with presence of a dominant high-pressure

Figure 4 showing satellite image at 0930Z on 06 May 2025 (Source: DGMET)

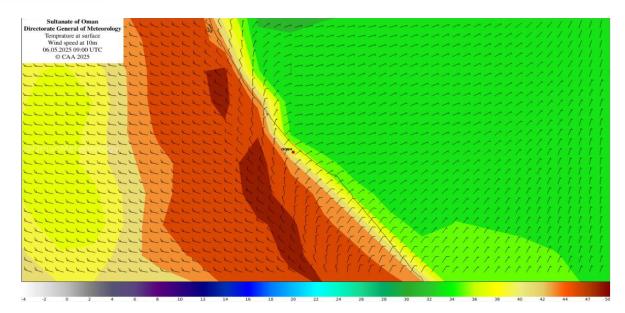
- At 0850 UTC, surface winds were reported at 06 knots from 020°, indicating a light northeasterly breeze, Temperature: 45°C and QNH: 1002 hPa.
- By 0950 UTC, wind speeds increased slightly to 10 knots from 280°, showing a shift to a moderate westerly direction with increase in Temperature to 46°C, QNH: 1002 hPa.
- Visibility remains good, and no precipitation or significant weather phenomena were observed during the reporting period.

Figure 5 showing surface temperature and 10m wind data at 0900 UTC on 06 May 2 (Source: DGMET)
