Oman Transport Safety Bureau

Preliminary Report

OTSB Case File No: AIFN-005/07/2024

Runway Excursion (RE) at Muscat International Airport (OOMS) on Runway 08L

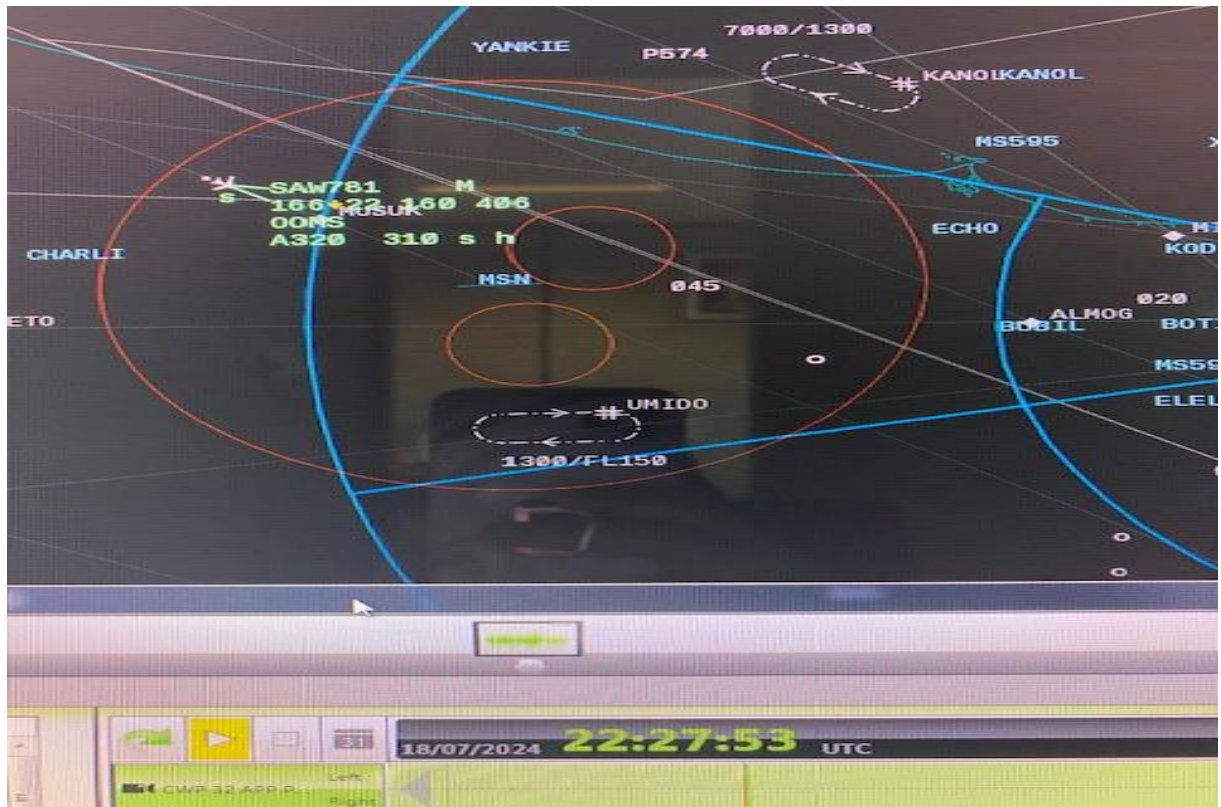
Figure 1: showing aircraft SAW781 at FL166 descending to FL160 when the flight crew first contacted MCT radar (Source: ANSIC)

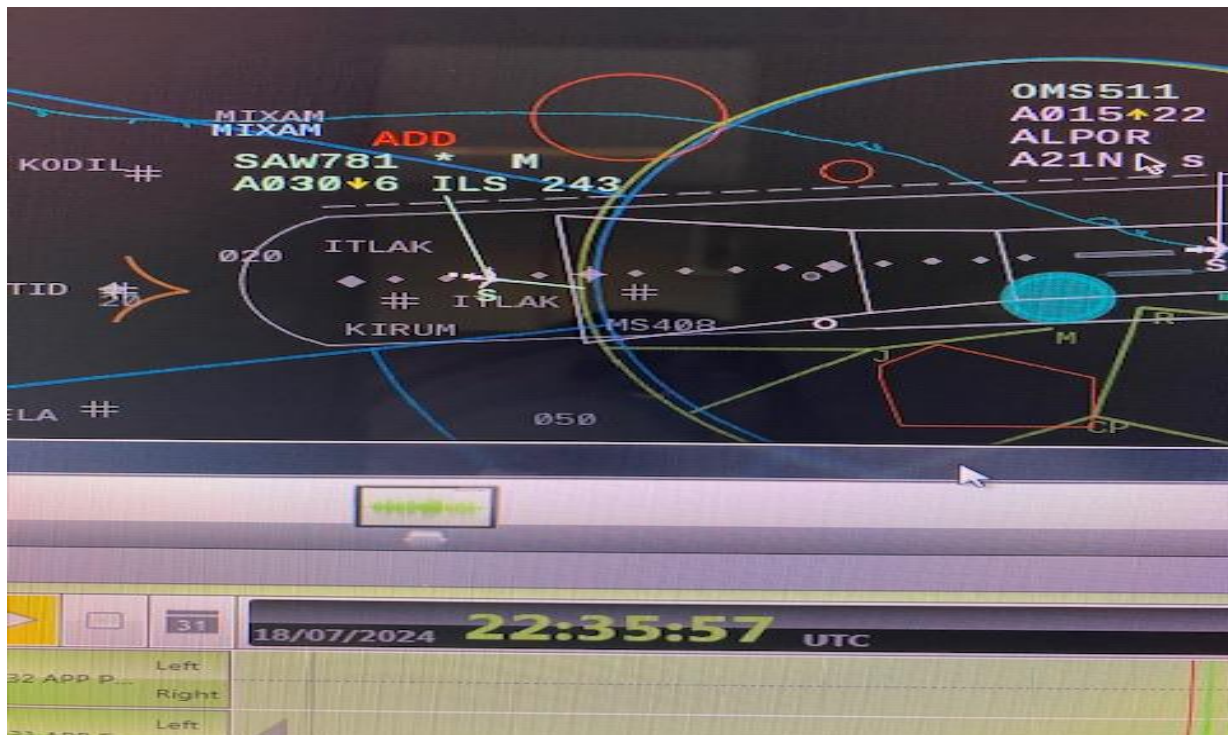
Figure 2: showing aircraft SAW781 established ILS RWY 08L (12 miles) from MCT (Source: ANSIC)

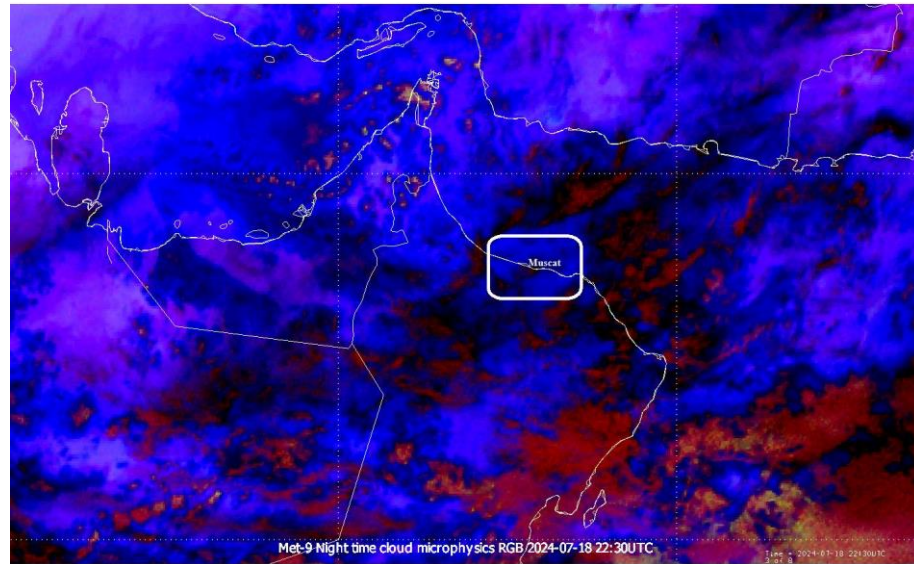
The Night time cloud microphysics RGB (NCM) and 10.8um infrared (IR) satellite images of the MeteoSat-9 Second Generation (MSG) show no significant clouds only high clouds are present over Sultanate of Oman on Muscat area before (2200Z, 2215Z, 2230Z) and after the time of incident (2245Z, 2300Z). As such, Visual meteorological conditions (VMC) prevailed during the time of accident.

Figure 5: showing satellite image at the time 2230Z on the 18th July 2024

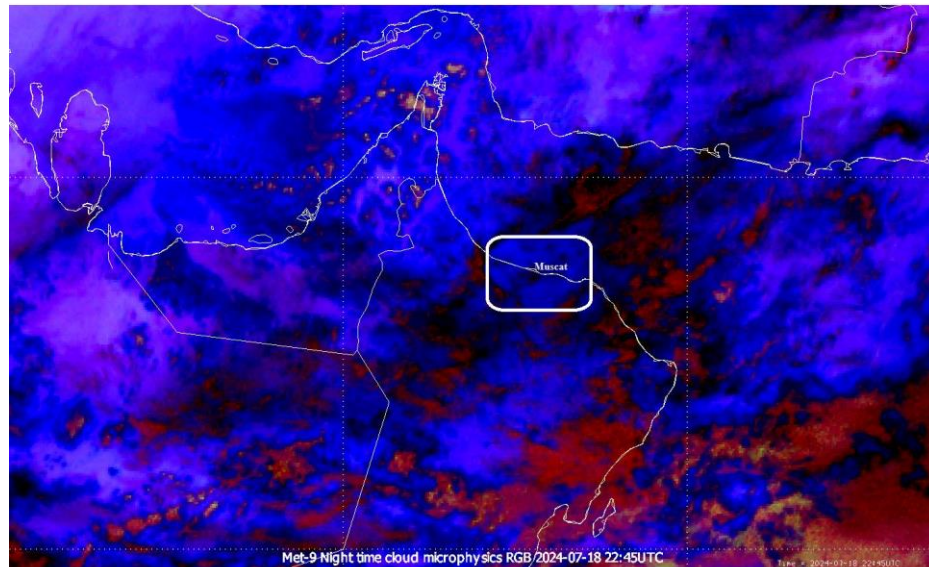
Figure 6: showing satellite image at the time 2245Z on the 18th July 2024

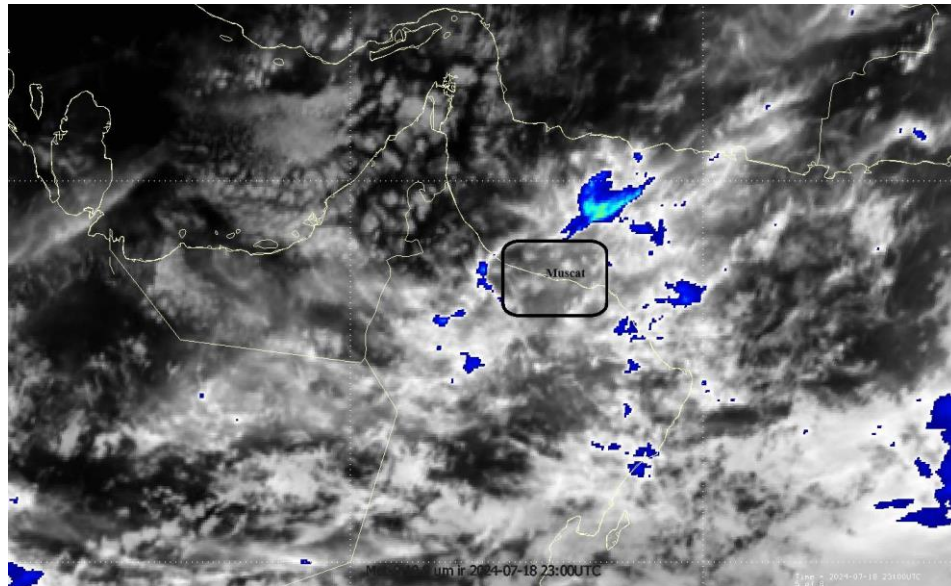
Figure 7: showing IR satellite image at the time 2245Z on the 18th July 2024

Conclusion: No significant weather was observed during the time of the incident.

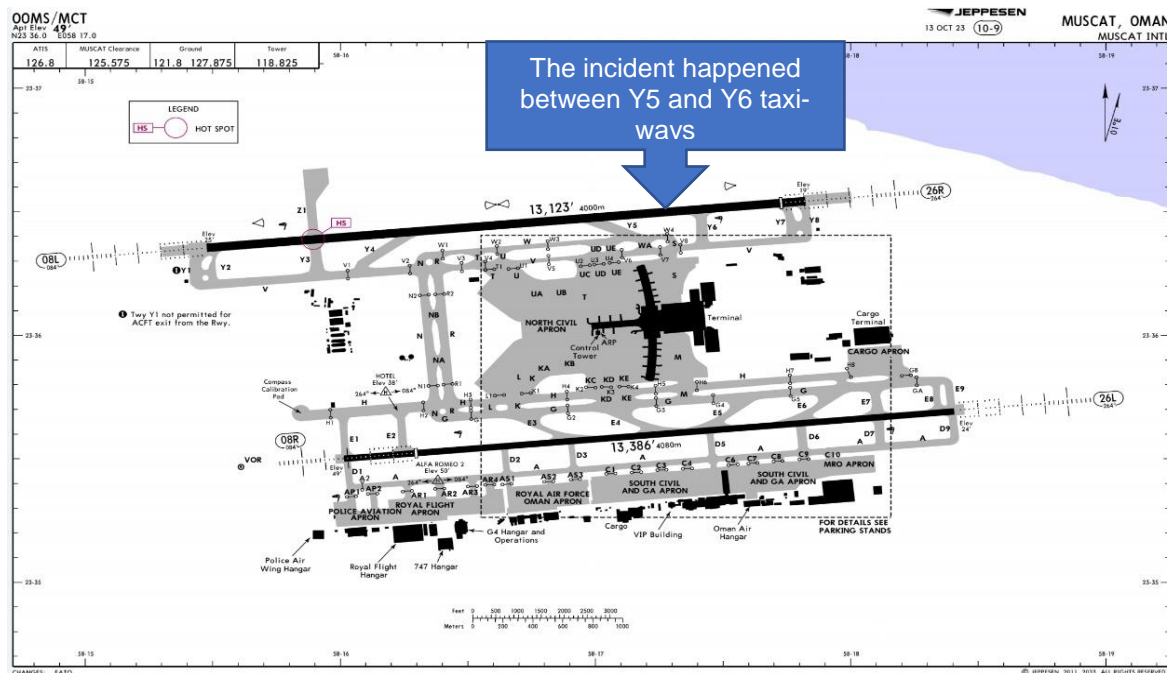
Figure 8: showing OOMS layout and where the incident happened
